NOx Sensors – Failure Causes & Fault Diagnosis

This Tech Tip is presented by:

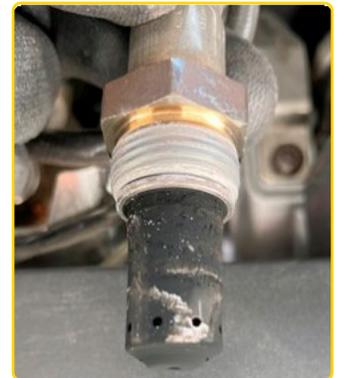
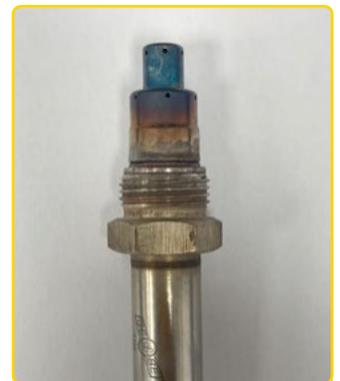
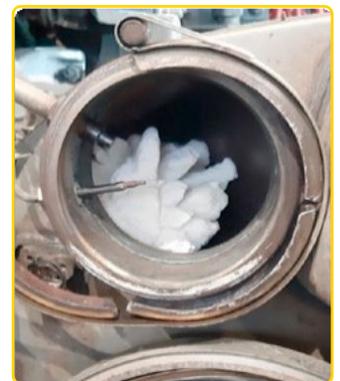
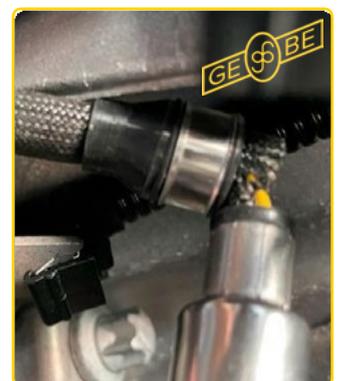
- Only a diagnostic tester that is up-to-date with the latest software can correctly read out the fault memory.
- In order to detect faults in the vicinity of the NOx sensor, all control units of the vehicle should always be read.
- Poor AdBlue® quality can affect the measurements made by the NOx sensor. A refractometer can be used to check the quality of AdBlue®: the target value is around 32.5%.
- Defective pump or dosage modules lead to massive deposits in the exhaust gas system.
- Defective wiring due to animal bites or smoldering damage as well as contact corrosion/breakage lead to the failure of the sensor.

Optical inspection: Visually check the NOx sensor after removal. In the case of heavy contamination by soot or AdBlue® residue, determine the cause. Check for discoloration of the sensor head. If the temperature is too high, it may indicate lean combustion. Damage to the connection thread must be repaired in advance with suitable tools. In most cases, it is an M22 thread with a 1.5 pitch. If the leak is not corrected, incorrect readings will occur.
