DSG7.03 DSG7 DQ200 REPAIR KIT

The DSG 7.03 DQ200 repair kit allows you to perform the repair of the DSG7 (0AM, 0CW DQ200) series gearboxes with a “dry clutch” in care of pressure problems. Pressure loss occurs as a result of cracks of structural failure (loss of tightness) in the area where the accumulator is attached to the valve body. The kit successfully eliminates the P17BF problem, common for DSG7 transmissions.

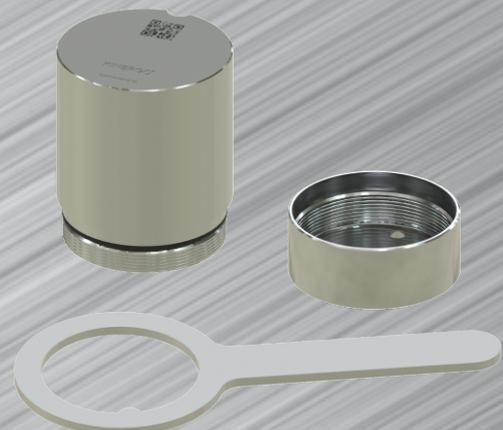
The repair kit allows you to repair the hydraulic plate without using welding, and eliminates the reformation of cracks at the junction of the valve body and the hydraulic accumulator.

- Compatible with all types of automatic transmissions of DSG7 DQ200 series.
- In most cases, repair is possible without removing the mechatronics from the car, for replacement it is enough to dismantle the tray.
- Eliminates the reoccurrence of cracks at the joint, as in the case of replacing only the valve body plate.
- Fast, simple and reliable installation process.
- Allows you to restore the functionality of the mechatronics even with a damaged hydraulic accumulator threaded fastener.
- Installation does not require additional modifications and settings no need to dismantle and replace the original hydraulic plate.
