Salt Spray Report

Test sample **LED Strip**

Model of the sample C-SF2J

Report No.: BEL20170000101058

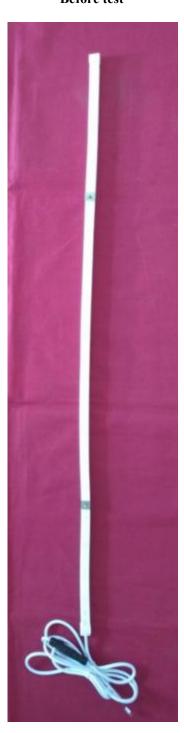
Before test

PHOTOGRAPHS OF TEST SAMPLE

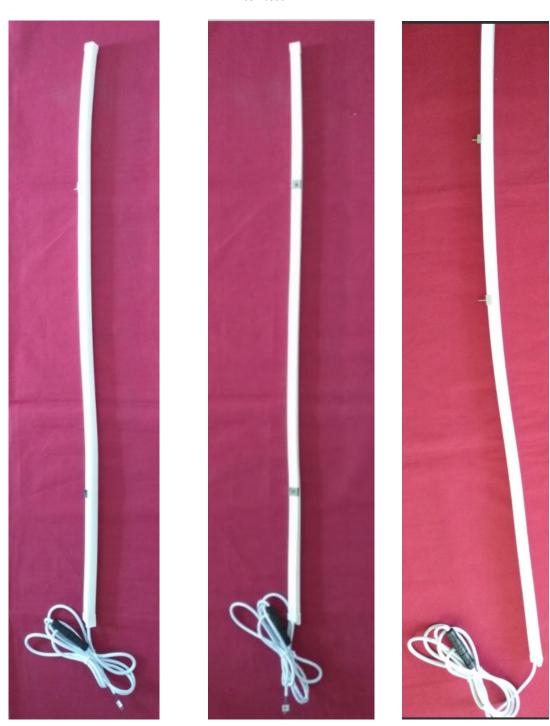
After test

Equipment:TMJ-9702 salt spray equipment		
Test Conditions		
Conditions	Setting	Actual record
Concentration of salt solution	5%NaCL	5%
Test room Temperature	35%C±1℃	35℃
Saturated air barrel temperature	47%C ±1℃	47 ℃
Test room relative humidity	More than 84%	90%RH
Pressure of compressed air	1±0.1KG/CM ²	0.9KG/CM ²
Collected volume of salt spray	1-2ML/CM ² /H	1.8ML/CM ² /H
PH of salt solution	7±0.5	7
Test duration:96 hours	Time in	8:30AM,2017.10.07
	Time out	10:00AM,2017.10.11
The appearance after testing: OK		
Acceptable Criteria: 1.Corrosion		area based on the test standard \leq 0.005% (\checkmark)
2.According		to the customer requirement:()
3.According		to the other method: ()
Judgement: (√) Accepted () Rejected () Other option
